# Understanding Rotator Cuff Tears and Repairs

by **Kevin Michael Kaplan, MD**  
*Sports Medicine, Joint Replacement*  
SAN MARCO

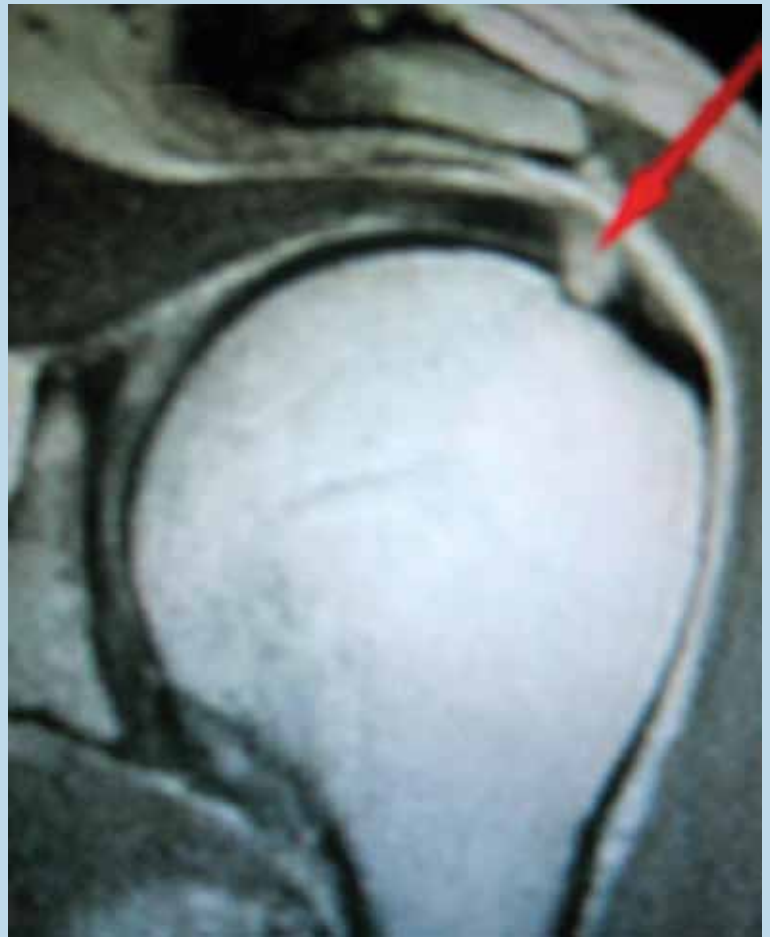
Figure 1: MRI demonstrating a rotator cuff tear. The arrow points to a gap in the tendon, indicative of a tear.

Diagnosis of a rotator cuff tear can be made with a combination of history, physical exam, and radiographic studies. By thoroughly examining patients with shoulder pain and tests specific to this type of injury, patients may be sent for a confirmatory test such as a magnetic resonance imaging (MRI). This imaging modality is the test of choice to evaluate for a rotator cuff tear (Figure 1).

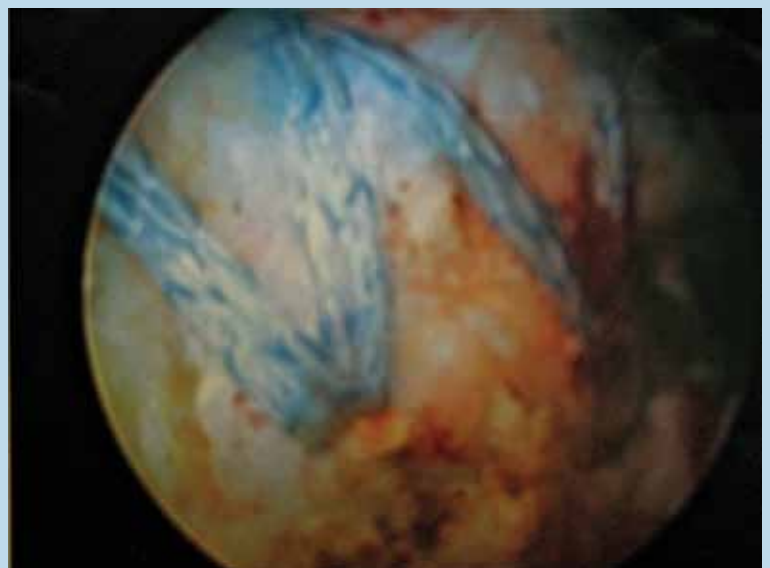
Figure 2: The NET Bridge utilizes several specially designed sutures including the above shown fibertape, in a novel configuration to achieve the strongest and most durable repair.

In a soon to be published article in the orthopaedic surgery literature, I describe a technique (The NET bridge designed by Dr. Neal ElAttrache) that I tested in a biomechanics laboratory and found it to be the strongest rotator cuff repair reported to date. The NET bridge utilizes a combination of high strength suture materials in a novel configuration to achieve the maximal strength of repair while also maximizing the contact between the torn tendon and bone of the humerus (Figure 2). One of the biggest pitfalls with rotator cuff surgery is avoiding a re-tear of the tendon. However, a common complication that can also be a considerable challenge is post-operative stiffness. By providing a stronger, more durable repair in utilizing the NET bridge, my patients can expect an early return to their daily activities through range of motion exercises and shorter time in a sling.
